**Flood Control Project Maintenance  
Levee Inspections**

## Maintenance Issue Types Only, Levee Inspection Report By Mile - Spring 2017

### Sutter Maintenance Yard Maintenance Area 0012

Waterway	Bank	Unit Miles	Inspection Start/End	Inspector
Unit No. 01 Colusa Drain	Left	11.06	03/16/2017 03/16/2017	Bob Duffey

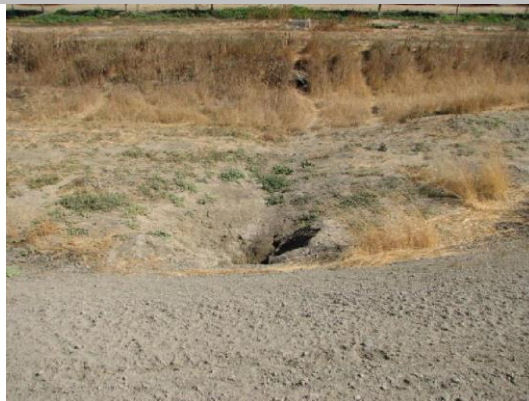
Photo 1 of 3 : UCIP\_SP\_2017\_51779\_68973.jpg

FS\_ID:51779  
DS\_ID:17146  
EP\_NO: 9382  
Repair Type: Non-Urgent  
Crossing Status: Found  
UCIP Comments: 5/2/2017 WS is in good condition. LS inlet is more than 50% full of sediment. Pipe needs to be cleaned internally. (DWR Sutter Yard- A Freitag)10/17/2016 Minor sediment blocking the WS flap gate from opening. LS inlet still mostly full of sediment.(DWR Sutter Yard- A Freitag)9/29/2016 Crossing has been downgraded from Urgent to Non-Urgent WS flap gate is closed for flood season. Need to coordinate with owner to remove sediment blocking WS flap gate. (DWR UCIP - omagana)5/31/2016 WS flap gate is blocked from opening by sediment. LS inlet is over 50% full of sediment. (DWR Sutter Yard - a Freitag)5/4/2015 WS flap gate is blocked by sediment and unable to open. LS inlet is about 50% plugged with soil. Needs to be cleaned. (DWR Sutter Yard - a Freitag)6/17/2014 Same as last inspection. (DWR Sutter Yard - a Freitag)12/16/2013 Sediment against flapgate has been cleared and it can now function properly. (DWR Sutter Yard - a Freitag)7/16/2013 Sediment is built up against WS flapgate preventing it from opening. (DWR Sutter Yard - a Freitag)10/11/2012 Pipe is partially filled with soil. (DWR UCIP - wwylyie)

Intake at LS toe.

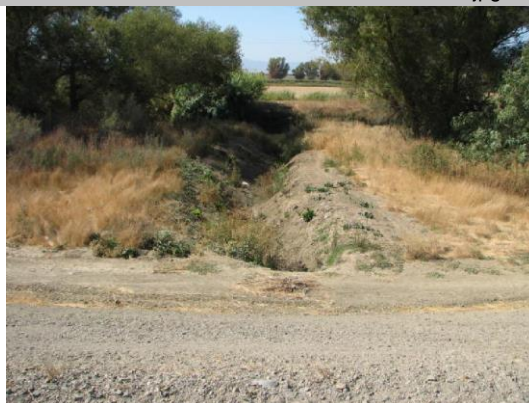
Photo 2 of 3 : UCIP\_SP\_2017\_51779\_68972.jpg

FS\_ID:51779  
DS\_ID:17146  
EP\_NO: 9382  
Repair Type: Non-Urgent  
Crossing Status: Found  
UCIP Comments: 5/2/2017 WS is in good condition. LS inlet is more than 50% full of sediment. Pipe needs to be cleaned internally. (DWR Sutter Yard- A Freitag)10/17/2016 Minor sediment blocking the WS flap gate from opening. LS inlet still mostly full of sediment.(DWR Sutter Yard- A Freitag)9/29/2016 Crossing has been downgraded from Urgent to Non-Urgent WS flap gate is closed for flood season. Need to coordinate with owner to remove sediment blocking WS flap gate. (DWR UCIP - omagana)5/31/2016 WS flap gate is blocked from opening by sediment. LS inlet is over 50% full of sediment. (DWR Sutter Yard - a Freitag)5/4/2015 WS flap gate is blocked by sediment and unable to open. LS inlet is about 50% plugged with soil. Needs to be cleaned. (DWR Sutter Yard - a Freitag)6/17/2014 Same as last inspection. (DWR Sutter Yard - a Freitag)12/16/2013 Sediment against flapgate has been cleared and it can now function properly. (DWR Sutter Yard - a Freitag)7/16/2013 Sediment is built up against WS flapgate preventing it from opening. (DWR Sutter Yard - a Freitag)10/11/2012 Pipe is partially filled with soil. (DWR UCIP - wwylie)

Outlet at WS toe.

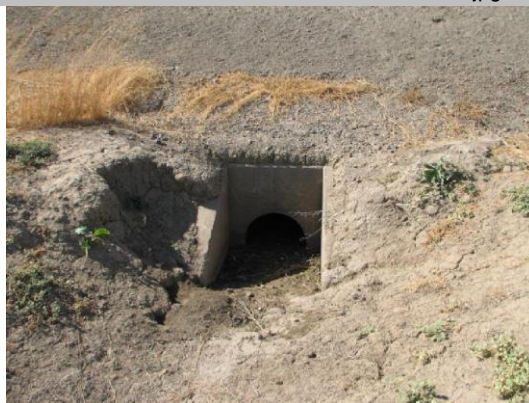
Photo 3 of 3 : UCIP\_SP\_2017\_51779\_68971.jpg

FS\_ID:51779  
DS\_ID:17146  
EP\_NO: 9382  
Repair Type: Non-Urgent  
Crossing Status: Found  
UCIP Comments: 5/2/2017 WS is in good condition. LS inlet is more than 50% full of sediment. Pipe needs to be cleaned internally. (DWR Sutter Yard- AFreitag)10/17/2016 Minor sediment blocking the WS flap gate from opening. LS inlet still mostly full of sediment.(DWR Sutter Yard- AFreitag)9/29/2016 Crossing has been downgraded from Urgent to Non-Urgent WS flap gate is closed for flood season. Need to coordinate with owner to remove sediment blocking WS flap gate. (DWR UCIP - omagana)5/31/2016 WS flap gate is blocked from opening by sediment. LS inlet is over 50% full of sediment. (DWR Sutter Yard - afreitag)5/4/2015 WS flap gate is blocked by sediment and unable to open. LS inlet is about 50% plugged with soil. Needs to be cleaned. (DWR Sutter Yard - afreitag)6/17/2014 Same as last inspection. (DWR Sutter Yard - afreitag)12/16/2013 Sediment against flapgate has been cleared and it can now function properly. (DWR Sutter Yard - afreitag)7/16/2013 Sediment is built up against WS flapgate preventing it from opening. (DWR Sutter Yard - afreitag)10/11/2012 Pipe is partially filled with soil. (DWR UCIP - wwylie)

Inlet and concrete headwall on LS toe.

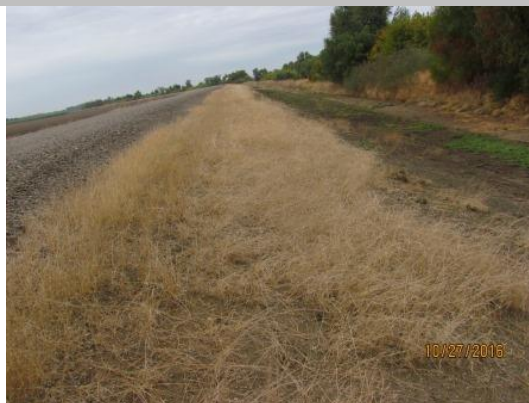
Photo 1 of 1 : SP\_2017\_MA0012\_299\_36\_20170315\_00010.jpg

View of the annual grass along the waterside slope.

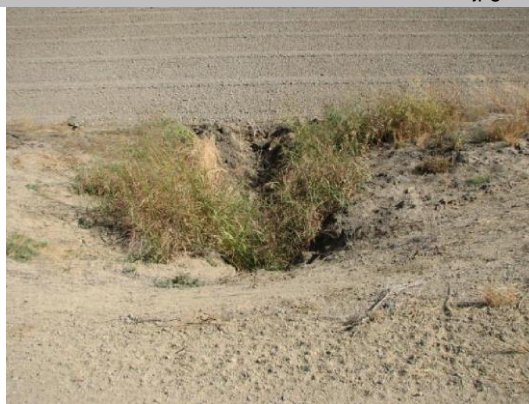
Photo 1 of 3 : UCIP\_SP\_2017\_51780\_68977.jpg

Comment Code					
Inspector Comment					
FS_ID:51780 DS_ID:17147 EP_NO: 9382 Repair Type: No Action Needed Crossing Status: Found UCIP Comments: 5/2/2017 Crossing appears to be in good condition. (DWR Sutter Yard- AFreitag)10/17/2016 Crossing appears to be in good condition. This is a gravity for the LS.(DWR Sutter Yard- AFreitag)5/31/2016 Crossing appears to be in good condition.5/4/2015 Crossing is in good condition. No issues.6/17/2014 Same as last inspection.12/16/2013 Same as last inspection.7/16/2013 Same as last inspection. FIELD_STRUCT_DESC: 24-inch corrugated metal drainage pipe through the levee, 13 feet below the crown. Flap gate, concrete headwall and grouted cobble spillway on the waterside (WS). Concrete headwall located on the landside (LS). (Automatic Board Order (ABO) issued as Permit No. 9382, 1974 - Baber). [Additional Reference(s): DWR Levee Log, 2005. USACE Sacramento O&M Manual 132, October 1959 (HLM 1.4)] FS Date: 5/2/2017 1:40:20 PM

Intake on LS toe.

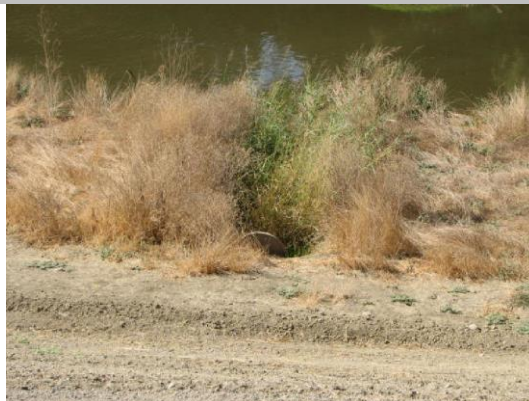
Photo 1 of 3 : UCIP\_SP\_2017\_51782\_68984.jpg

FS\_ID:51782  
DS\_ID:17149  
EP\_NO: 9382  
Repair Type: Non-Urgent  
Crossing Status: Found  
UCIP Comments: 5/2/2017 WS flapgate buried by sediment. Needs to be dug out. (DWR Sutter Yard- A Freitag)10/17/2016 Crossing appears to be in good condition. This is a gravity drain for the LS. (DWR Sutter Yard- A Freitag)5/31/2016 LS inlets was partially plugged. WS flapgate was clear of sediment and able to operate properly.5/4/2015 WS flapgate is blocked by sediment and unable to open. LS inlet is plugged by silt and wood chippings. Needs to be cleaned.6/17/2014 Flap gate was cleaned out and is fully closed. LS inlet still partially full of soil.12/16/2013 Same as last inspection. WS flapgate still needs to be cleaned out and shut.7/16/2013 Same as last inspection. Make sure flapgate is closed before highwater season.10/11/2012 Inlet on LS filled partially with soil. Outlet blocked with soil and the flap gate wont close.

Outlet on WS toe.

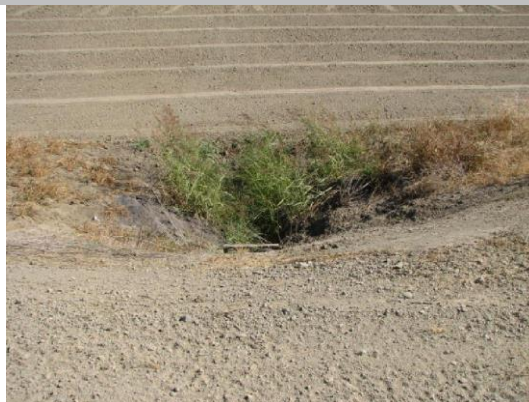
Photo 2 of 3 : UCIP\_SP\_2017\_51782\_68983.jpg

Inlet on LS toe.

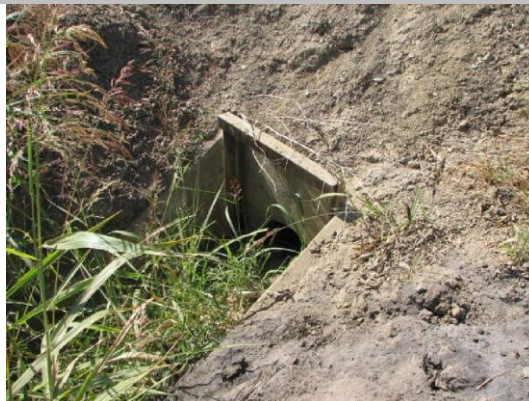
Photo 3 of 3 : UCIP\_SP\_2017\_51782\_68982.jpg

FS\_ID:51782  
DS\_ID:17149  
EP\_NO: 9382  
Repair Type: Non-Urgent  
Crossing Status: Found  
UCIP Comments: 5/2/2017 WS flapgate buried by sediment. Needs to be dug out. (DWR Sutter Yard- A Freitag)10/17/2016 Crossing appears to be in good condition. This is a gravity drain for the LS. (DWR Sutter Yard- A Freitag)5/31/2016 LS inlets was partially plugged. WS flapgate was clear of sediment and abale to operate properly.5/4/2015 WS flapgate is blocked by sediment and unable to open. LS inlet is plugged by silt and wood chippings. Needs to be cleaned.6/17/2014 Flap gate was cleaned out and is fully closed. LS inlet still partially full of soil.12/16/2013 Same as last inspection. WS flapgate still needs to be cleaned out and shut.7/16/2013 Same as last inspection. Make sure flapgate is closed before highwater season.10/11/2012 Inlet on LS filled partially with soil. Outlet blocked with soil and the flap gate wont close.

Concrete U shaped headwall at LS inlet.

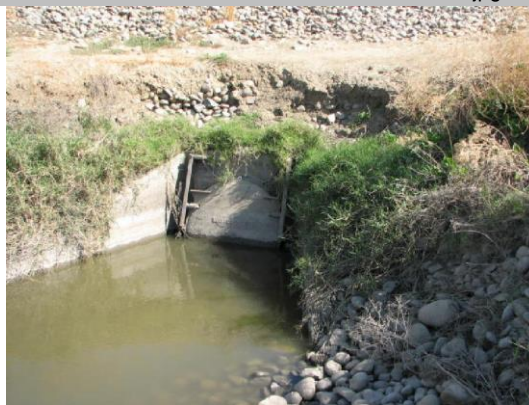
Photo 2 of 3 : UCIP\_SP\_2017\_51785\_68990.jpg

FS\_ID:51785  
DS\_ID:17150  
EP\_NO: 9387  
Repair Type: No Action Needed  
Crossing Status: Found  
UCIP Comments: 5/2/2017 Crossing appears to be in good condition. (DWR Sutter Yard- A Freitag)10/17/2016 Crossing appears to be in good condition. (DWR Sutter Yard- A Freitag)5/31/2016 Crossing appears to be in good condition. Attached photo showing location of LS inlet.5/4/2015 WS flapgate mostly underwater but could tell it was blocked open by something. LS inlet is located about 1/4 mile north along the side of the roadway.6/17/2014 Same as last inspection.12/16/2013 Pipe was flowing water and flap gate was being pushed open. Cannot verify if it will close all the way.7/16/2013 Same as last inspection. Was told inlet is about 1/4 mile down road way next to house. Will try to get coordinates for inlet.10/11/2012 No inlet could be located on LS. Flap gate partially blocked and will not close completely.

Flap gate and concrete headwall at WS toe.

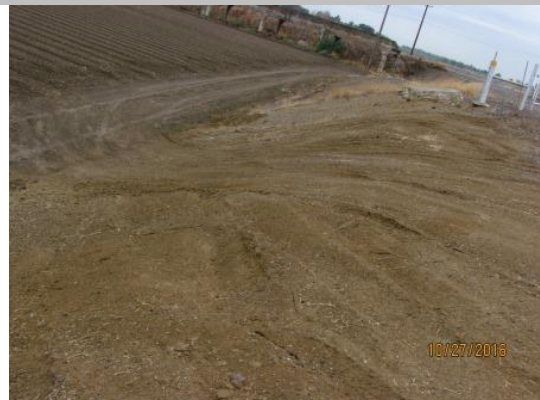
Photo 1 of 1 : SP\_2017\_MA0012\_299\_35\_20170315\_00009.jpg

LM Start	1.81	Rating **	M	Issue No.	35
LM End	1.81	Issue Type +	Ma	Location *	LS
Category	Earthen Levee		GPS Latitude/Longitude		
			Start	End	
Item	Slope Stability		39.057393 °	39.057393 °	
			-122.003452 °	-122.003452 °	
DWR ID	DWR_MA0012_01_f_2016_35

View of the slope instability caused by vehicles along the landside slope.

S3 : Repair the levee slope damaged by vehicle traffic and prevent access where possible.

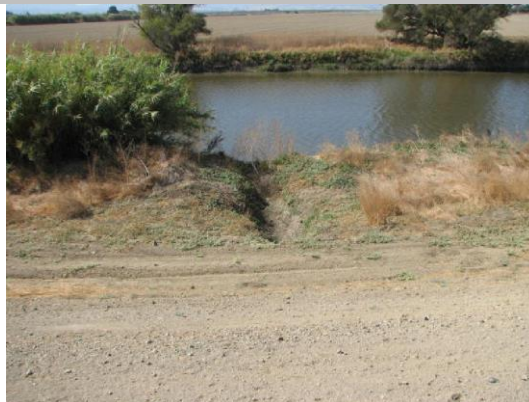
Photo 1 of 3 : UCIP\_SP\_2017\_51786\_68994.jpg

FS\_ID:51786  
DS\_ID:17151  
EP\_NO: 9391  
Repair Type: Non-Urgent  
Crossing Status: Found  
UCIP Comments: 5/2/2017 Both ends of pipe buried. (DWR Sutter Yard- AFreitag)10/17/2016 Appears abandoned. Both pipe ends are completely buried. (DWR Sutter Yard- AFreitag)9/29/2016 Crossing has been downgraded from Urgent to Non-Urgent both pipe ends are buried. Having both ends buried prevents water from flowing from WS to LS during flood season. Need to contact owner and have owner coordinate with CVFPB to comply with Title 23. (DWR UCIP - omagana)5/31/2016 Both pipe ends are buried. Pipe is non-operational. (DWR Sutter Yard - afreitag)5/4/2015 LS and WS ends are blocked with soil. Pipe is inoperable as it is. (DWR Sutter Yard - afreitag)6/17/2014 Same as last inspection. (DWR Sutter Yard - afreitag)12/16/2013 Same as last inspection. (DWR Sutter Yard - afreitag)7/16/2013 LS inlet is completely filled with soil. Needs to be cleaned out. (DWR Sutter Yard - afreitag)10/11/2012 Inlet is partially filled with soil. (DWR Sutter Yard - wwylie)

WS view of outlet.

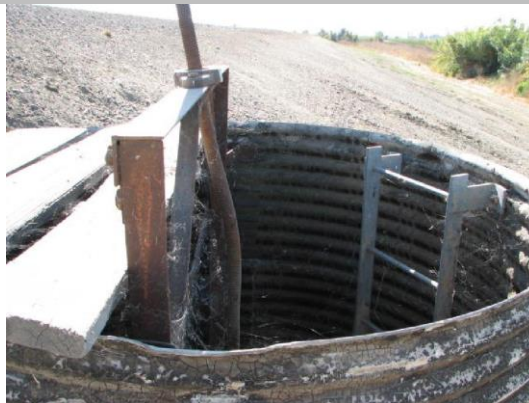
Photo 3 of 3 : UCIP\_SP\_2017\_51789\_69008.jpg

FS\_ID:51789  
DS\_ID:17154  
EP\_NO: 9388  
Repair Type: Urgent  
Crossing Status: Found  
UCIP Comments: 5/2/2017 WS slidegate stem is still bent, wheel to operate gate is missing. Needs a cover made for the standpipe to prevent falls. (DWR Sutter Yard- A Freitag)10/17/2016 Slide gate stem is still and the gate appears to be inoperable. (DWR Sutter Yard- A Freitag)5/31/2016 Slide gate stem is still bent. WS flap gate is chained open. (DWR Sutter Yard - a Freitag)5/4/2015 Slide gate stem is still bent. Gate looks to be unable to close all the way. (DWR Sutter Yard - a Freitag)6/17/2014 Same as last inspection. (DWR Sutter Yard - a Freitag)12/16/2013 Slide gate stem is still bent. WS flapgate was closed. (DWR Sutter Yard - a Freitag)7/16/2013 Water flowing through pipe so screw gate definitely not closed. Was told NOV's have been sent for owner to replace stem. Flap gate gets closed for flood season. (DWR Sutter Yard - a Freitag)10/11/2012 Slide gate inoperable, but appears to be in closed position. Flap gate held in open position. Good candidate for video inspection when, if ever, dry. (DWR UCIP - wwyllie)

Bent screw for slide gate at WS shoulder.

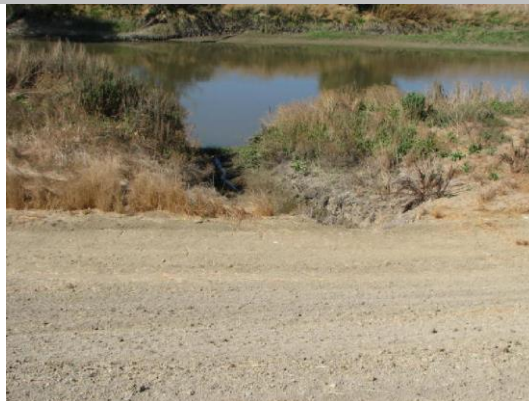
Photo 1 of 3 : UCIP\_SP\_2017\_51795\_69026.jpg

FS\_ID:51795  
DS\_ID:17158  
EP\_NO: 9390  
Repair Type: No Action Needed  
Crossing Status: Found  
UCIP Comments: 5/2/2017 Crossing appears to be in good condition. There is minor sediment build up in front of the WS flap gate/ (DWR Sutter Yard- A Freitag)10/17/2016 Crossing appears to be in good condition. (DWR Sutter Yard- A Freitag)5/31/2016 Crossing appears to be in good condition.5/4/2015 Corssing appears to be in good condition. No noticeable issues to report.6/17/2014 Same as last inspection.12/16/2013 Same as last inspection.7/16/2013 New flapgate installed on WS pipe end.10/11/2012 Flap gate broken on WS, Pipe shows significant rust at outlet. This is a good candidate for video inspection.  
FIELD\_STRUCT\_DESC: 36-inch corrugated metal drainage pipe though the levee, 20 feet below the crown. Pump on metal pier in landside (LS) channel. 40-inch steel standpipe at LS toe. Flap gate and concrete headwall on the waterside (WS). Concrete headwall on the LS. (Automatic Board Order (ABO) issued as Permit No. 9390, 1974 - Profpe). [Additional Reference(s): DWR Levee Log, 2005. USACE Sacramento O&M Manual 132, October 1959 (HLM 4.87)]

Outlet channel on WS toe.

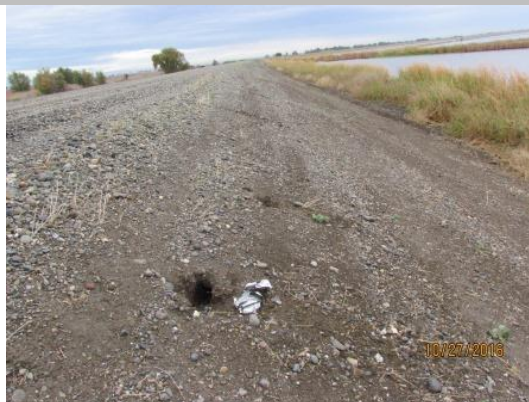
Photo 1 of 1 : SP\_2017\_MA0012\_299\_32\_20170315\_00006.jpg

View of the rodent holes along the landside slope.

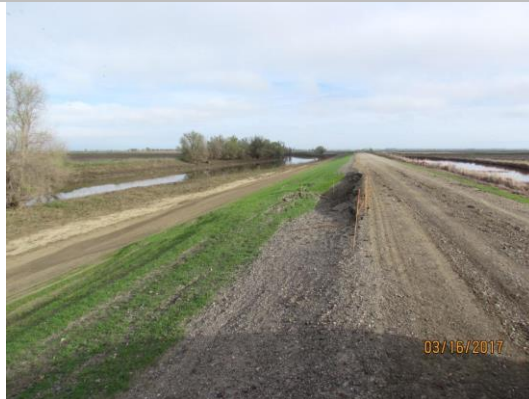
Photo 1 of 1 : SP\_2017\_MA0012\_299\_50\_20170328\_00087.jpg

View of the slough on the waterside slope.

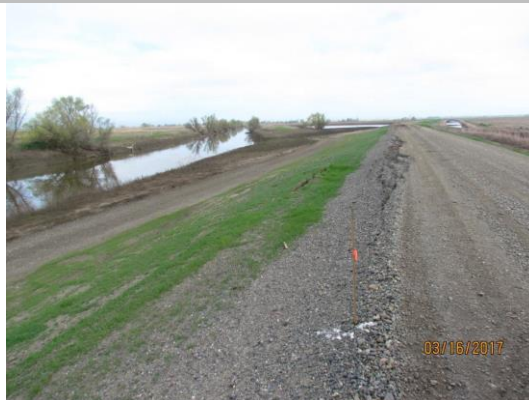
Photo 1 of 1 : SP\_2017\_MA0012\_299\_51\_20170328\_00088.jpg

View of the slough on the waterside slope.

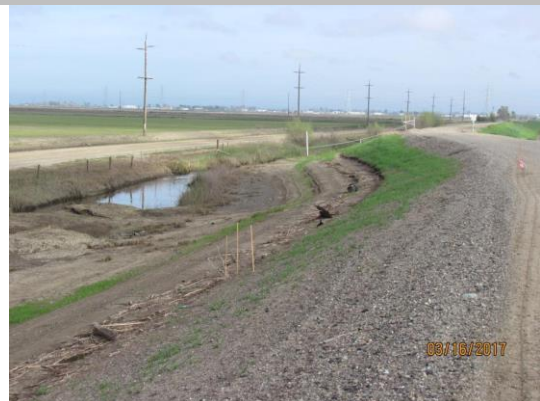
Photo 1 of 1 : SP\_2017\_MA0012\_299\_52\_20170328\_00089.jpg

View of the erosion along the waterside slope.

E2 : Schedule repair of erosion site prior to the next inspection.

Repair the erosion along the waterside slope

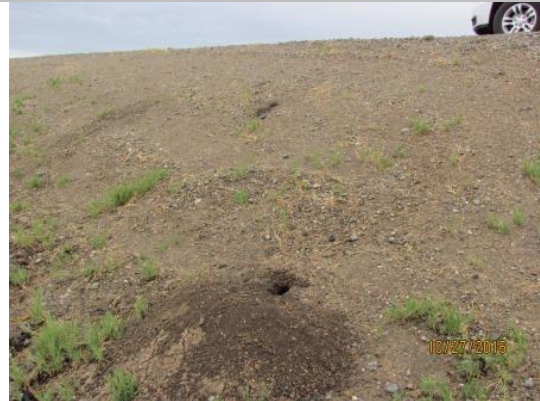
Photo 1 of 1 : SP\_2017\_MA0012\_299\_24\_20170315\_00004.jpg

View of the rodent holes along the landside slope.
